**MITTEILUNG**  
**Gurtzeuge**

Bezug: Mitteilung über eine Technikinformation der FAI von 1/2009 **W.N. 22** ,  
Loop-Bruch am Riser Rigging Innovation

Betroffene Muster: Riser der Firma Rigging Inovation  
**Bitte angehängte Service Bulletin SB 1538 von Rigging Innovation und  
die Technische Mitteilung W.N.22 FAI beachten!**

**DATE:** JULY 18, 2000    **SERVICE BULLETIN #** SB-1538    **# OF PAGES:** 2  
**SUBJECT:** MAIN RISERS  
**STATUS:** RECOMMENDED

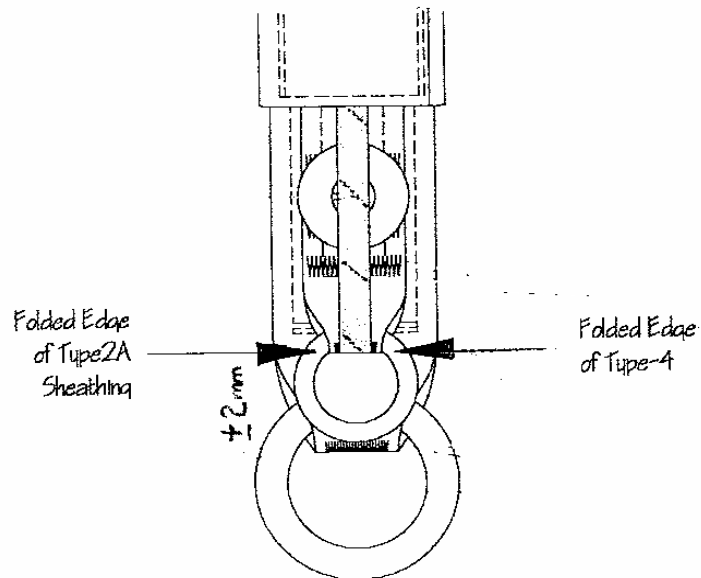
On all solo rigs and all types of riser style, one inch type 17 mini rings, type 8 mini rings and standard type 8 with the larger rings, the length of the locking loop should be level (+/- 2mm) with the end of the fold of the webbing that retains the small ring when the riser is laid flat with some tension applied to the small ring.

**Typical view of locking loop length**

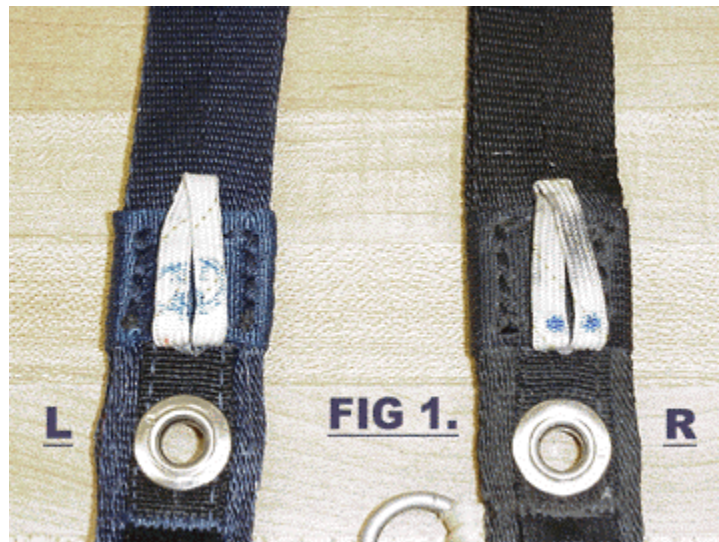
In January, 2000, a pair of main risers was found in the field where the locking loops were not bartacked and consequently one of the loops pulled out, releasing the riser. Fortunately this did not result in any injury. These risers were relatively new and presumed to have been manufactured within the previous few months. At the time, we believed that this was an isolated occurrence but to preclude a re-occurrence of the problem, RI implemented an additional manufacturing inspection of the riser loop bartacks.

In July 2000, a second pair of risers was found with missing bartacks. These risers had over a hundred jumps on them before the loop pulled free. It would appear that these were manufactured in the same time period as the first risers but this cannot be determined precisely. Because it is impossible to positively identify the time frame or batch lot of the risers, RI feels that ALL main risers should be inspected according to the following Service Bulletin.

- d. If the loop holds, mark the rear side of the loop with two dots of a BLUE permanent marker (Fig. 1R). The riser may then be returned to service. Check to make sure no damage was done to the loop during the test.
4. All new risers manufactured after January 2000 will have an identifying QC stamp on the rear of the locking loop as in Fig. 1L and do not need to be checked and are not subject to this Service Bulletin.
